# Release Notes for the Cisco 678 ADSL Router

**March 23, 2000**

These release notes discuss features, caveats, and open issues for the Cisco 678 asymmetric digital subscriber line (ADSL) router as of Release 2.3.0 of the Cisco Broadband Operating System (CBOS). This is the first supported release of the Cisco 678 ADSL router.

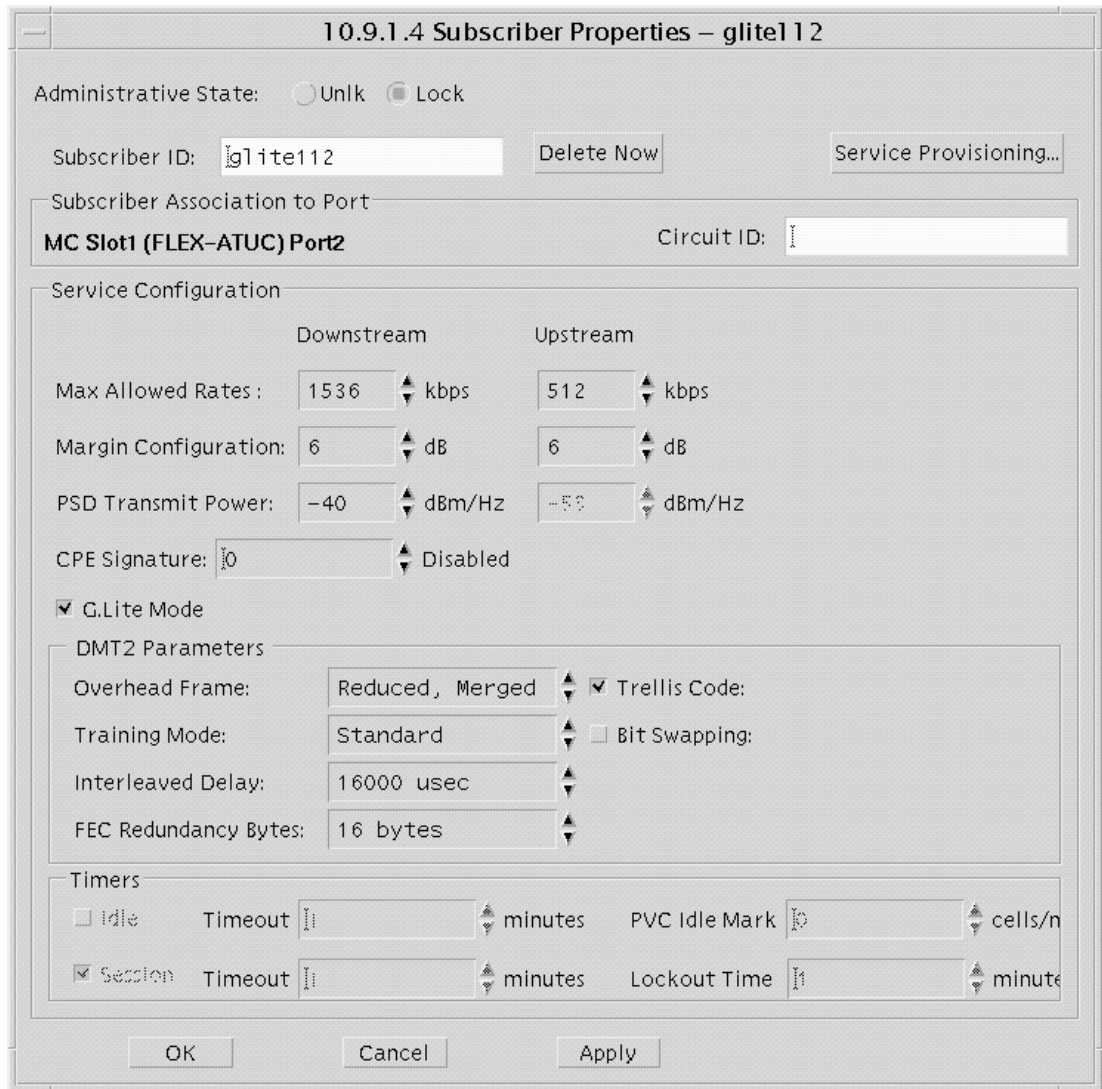
- 
- Step 1** Ensure the service configuration for a service user shows the G.Lite Mode is enabled. Within ViewRunner, open the Subscriber Profiles window and check the G.Lite Mode check box. (See Figure 1.)

Figure 1 G.Lite Mode Enabled in the ViewRunner Subscriber Profiles Window
